Manhole Inspection Summary

Manhole # S11EE2011MH

Insp Date: **10/31/06 9:38 AM**

Location Address: **2301 CROSS COUNTRY BLVD**

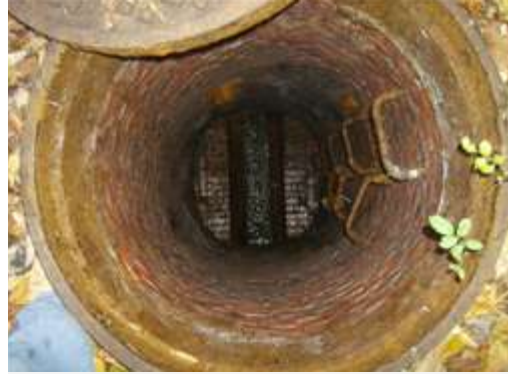
Top View

☐ Parged ☒ **Debris** (not Condition related)

Count: **9** Missing: **0** ☒ **Corroded**

☒ **Evidence Of Surcharge** Depth: **5** (ft.) ☐ Active Surcharge Present

Corroded steps. Evidence of surcharge - Bench debris.

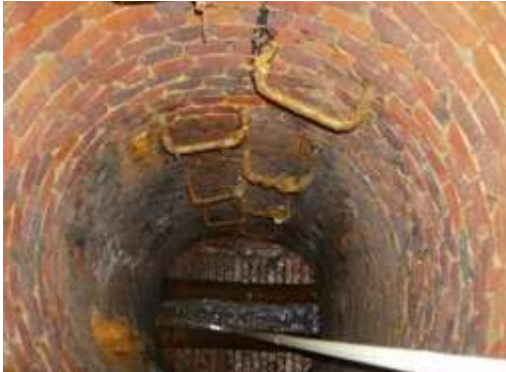
Defect

Infiltration: ☐ None ☒ **Joint** ☐ Cracks ☐ Mortar ☐ Roots ☒ **Wall**

Infiltration: ☐ None ☐ Joint ☐ Cracks ☐ Mortar ☐ Roots ☒ **Wall**

Adjustment and Barrel infiltration.
